## **IMIDE/GRAPHITE COMPOSITE DEGRADATION MECHANISM**

Final Report  
Contract No. N00019-94-C-0207  
Contract Amount: \$58,801.30  
Contract Competitively Awarded

NAV-0207-FM-95123-934

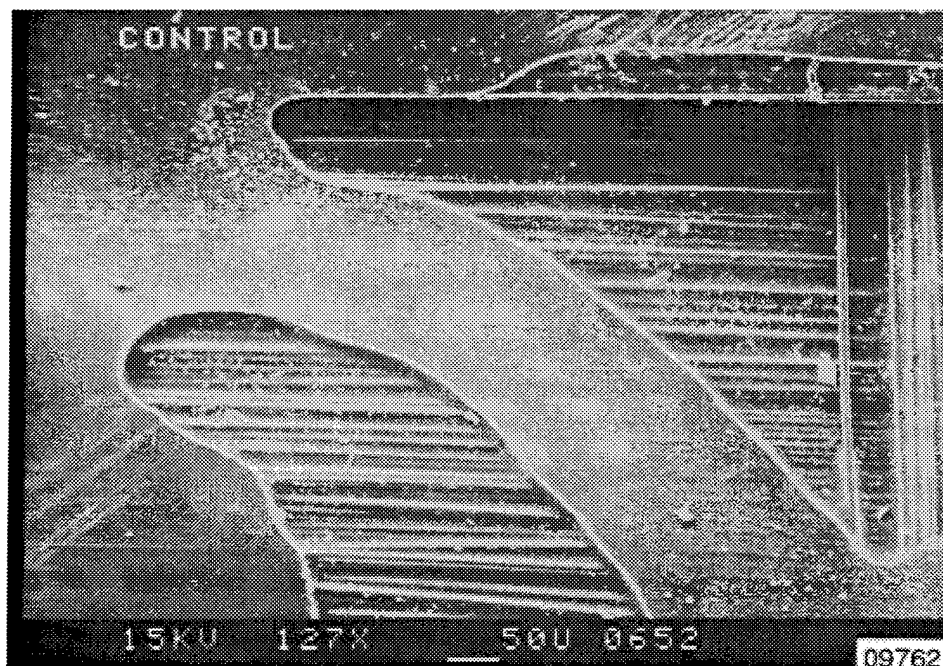
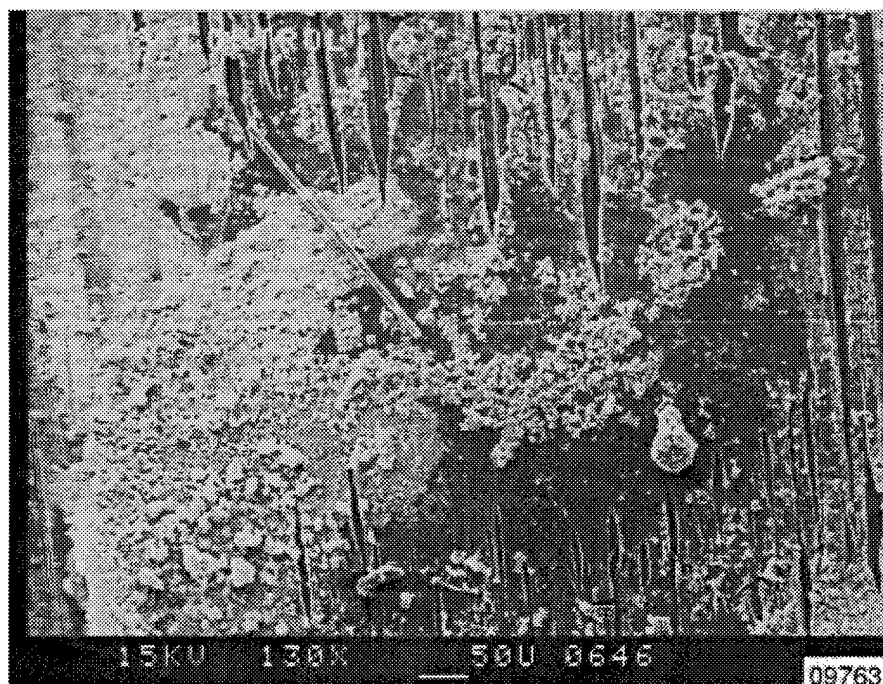
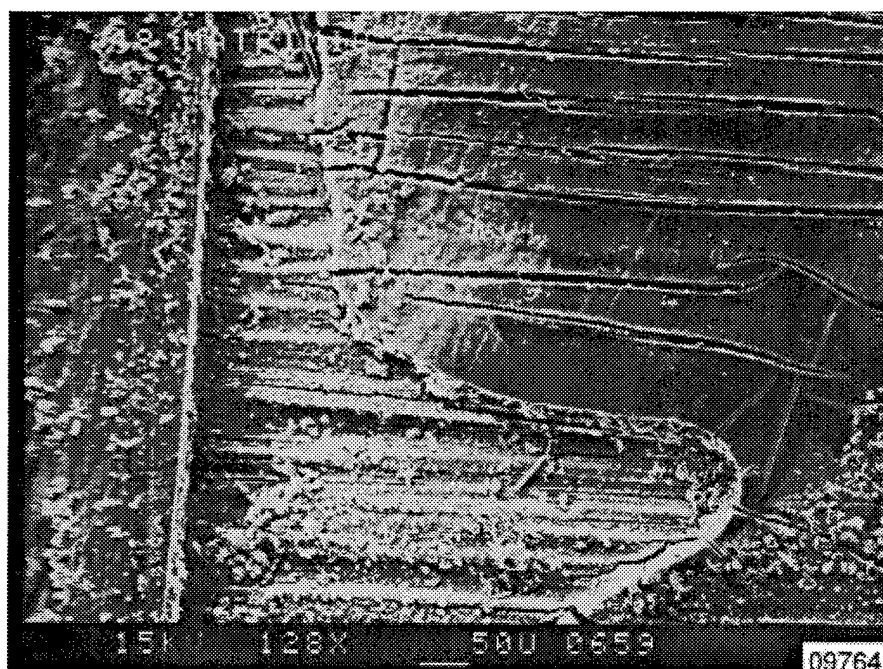
Figure 18 shows uncorroded control, 48 hr corroded control, and 48 hr corroded Matrimid samples at 130x. Figures 18b and 18c are taken well below the saltwater-jet fuel interface. Microcracking along the fiber direction is evident in both of the corroded samples. Similar regions from these samples, taken at 360x, are shown in Figure 19. A 1600x view of a region where microcracks are initiating in the 48 hr corroded sample is shown in Figure 20. The surface texture present here appears to be deposits of salts and corrosion by-product, and not pitting, since it is absent in other corroded areas. The small cracks appear to be propagating slowly until they reach a critical size. Unlike the microcracks in Figure 18, the edges are rough, as if caused by chemical degradation. The straight, smooth cracks in Figure 18 are more indicative of rapid, unstable crack growth, which probably occurred when initiating microcracks reached a critical size.

A) THE UNCORRODED CONTROL SAMPLE, TAKEN NEAR THE INTERSECTION OF WOVEN FIBER TOWS. EMBEDDED SURFACE FIBERS ARE SEEN IN TWO SMALL SURFACE VOIDS

**Figure 18. 130x views of BMI control and Matrimid samples which were uncorroded and corroded for 48 hr at 80°C**

B) THE CONTROL SAMPLE CORRODED FOR 48 HR, VIEWED IN A REGION WELL BELOW THE SALTWATER-JET FUEL INTERFACE. NOTE THE EXTENSIVE MICROCRACKING OF THE RESIN

C) THE MATRIMID SAMPLE CORRODED FOR 48 HR, VIEWED IN A REGION WELL BELOW THE SALTWATER-JET FUEL INTERFACE. NOTE THE SURFACE VOID SIMILAR TO THAT IN FIGURE 18A, AS WELL AS THE EXTENSIVE MICROCRACKING OF THE RESIN

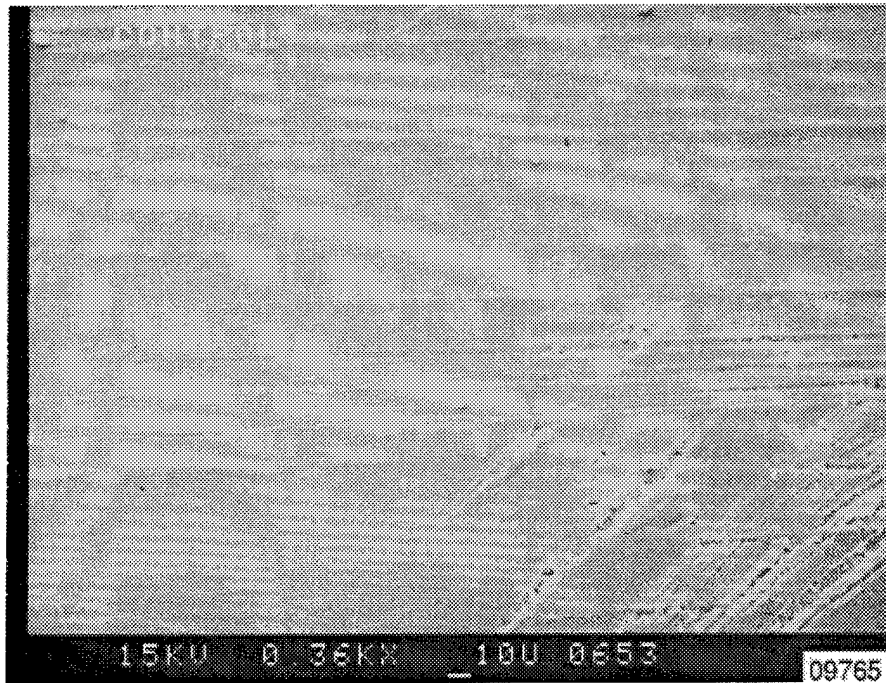
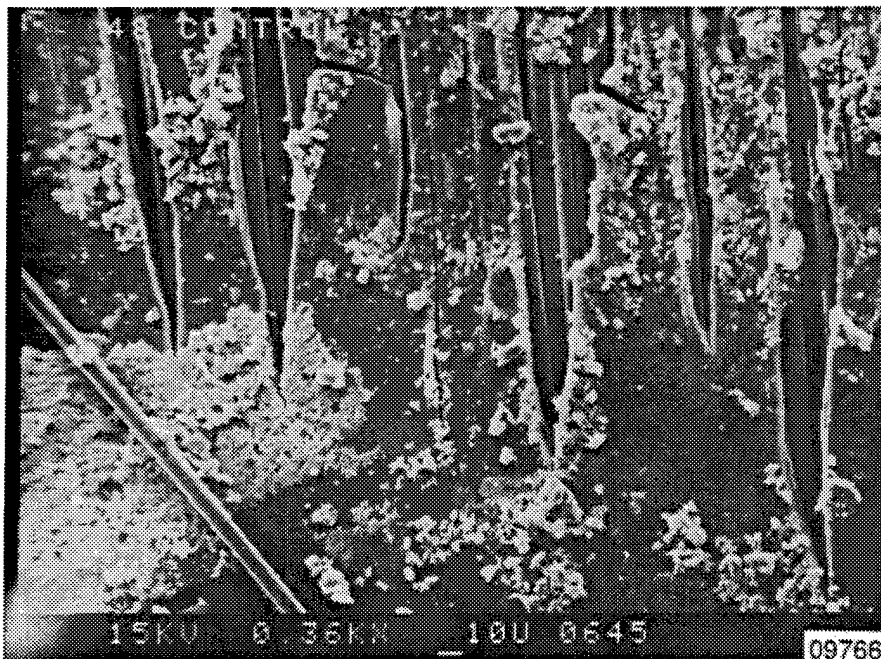
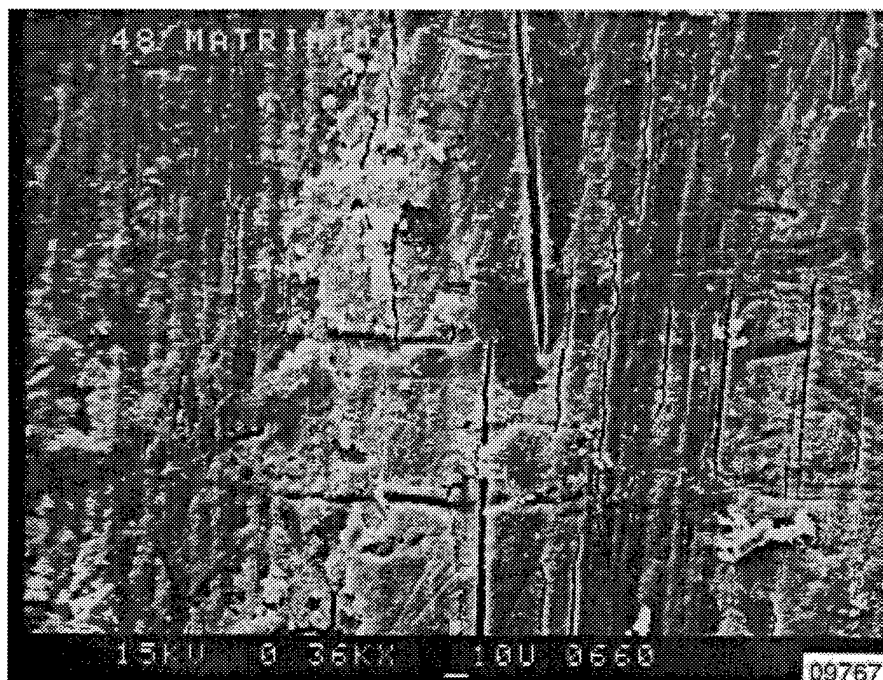
A) THE SURFACE OF THE UNCORRODED CONTROL SAMPLE. AN EXTENSIVE SURVEY OF THE SURFACE DID NOT ILLUMINATE ANY MICROCRACKS

B) THE CONTROL SAMPLE CORRODED FOR 48 HR, VIEWED IN A REGION WELL BELOW THE SALTWATER-JET FUEL INTERFACE. NOTE THE EXTENSIVE MICROCRACKING OF THE RESIN

**Figure 19. 360x views of BMI control and Matrimid samples which were uncorroded and corroded for 48 hr at 80°C**

C) THE MATRIMID SAMPLE CORRODED FOR 48 HR, VIEWED IN A REGION WELL BELOW THE SALTWATER-JET FUEL INTERFACE. NOTE THE EXTENSIVE MICROCRACKING OF THE RESIN

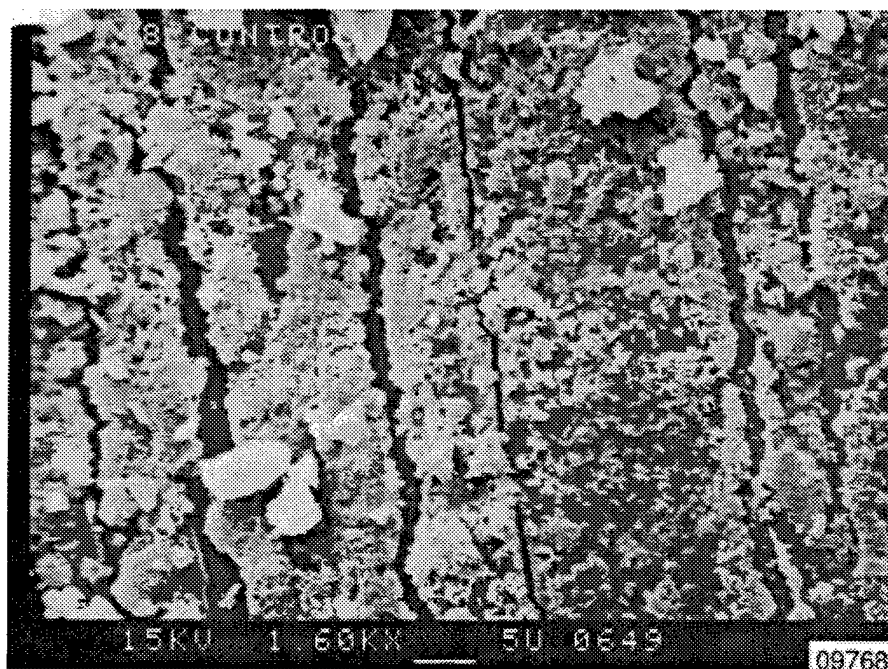
**Figure 20. Initiation zone of microcracks in a BMI control sample corroded for 48 hr**

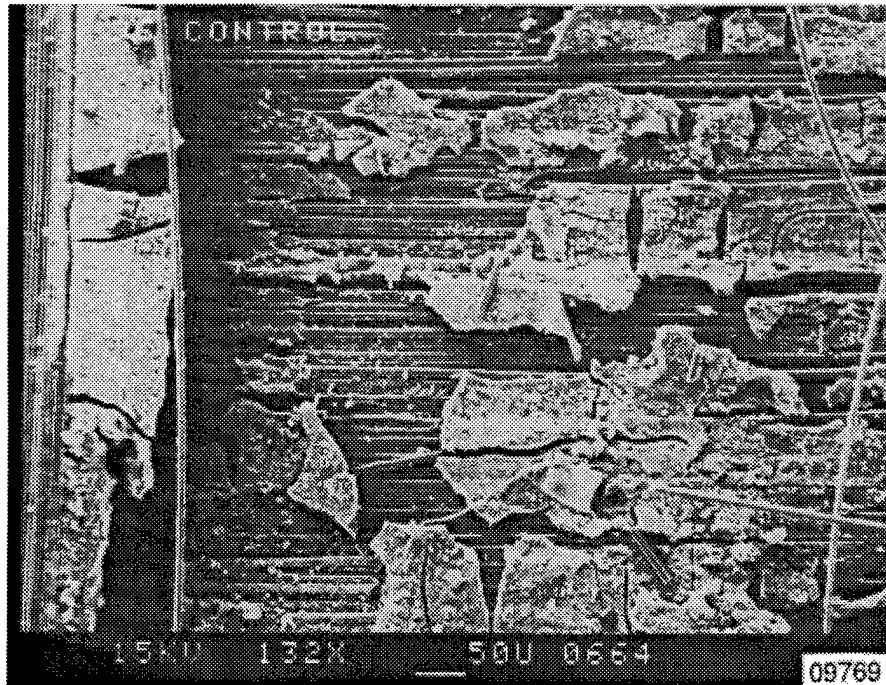
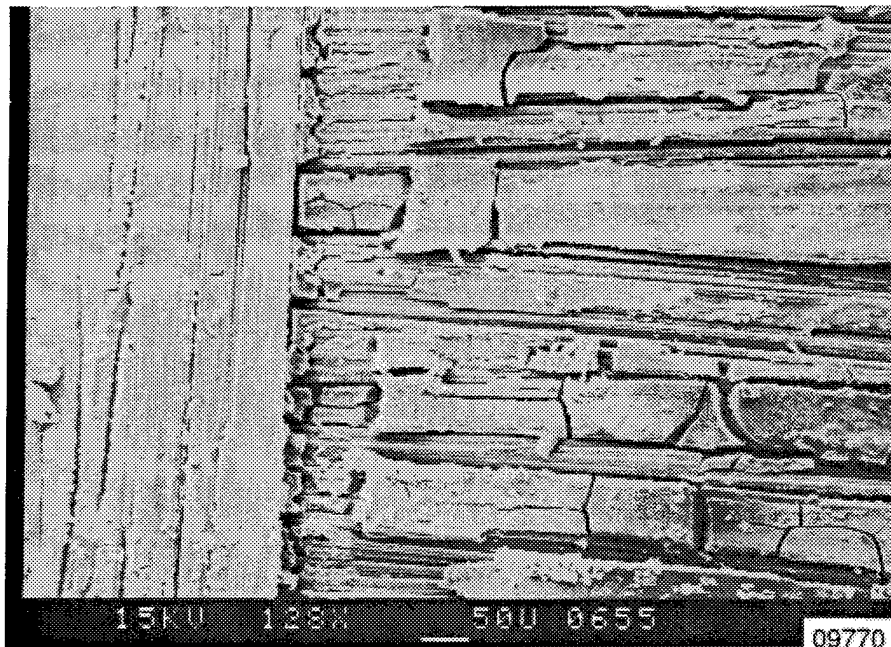
A region of the 48 hr corroded control and Matrimid samples, taken closer to the saltwater-jet fuel interface, is shown in Figure 21. Here, transverse microcracks have broken the surface resin into smaller fragments, and some of these fragments have begun to flake off. A closer examination of this flaking process is shown in Figure 22. Figure 22a shows a region where both longitudinal and transverse microcracking has occurred. When viewed at a higher tilt angle and at higher magnification in Figures 22b and 22c, the surface resin is seen to be peeling away from the carbon fiber beneath it. This confirms that after microcracks initiate, corrosion progresses locally along the fiber-matrix interface. The debonded region is observed to curl away from the fiber surface, further exposing the fiber. This curling is probably a result of the residual tensile stresses in the resin, which also drives propagation of the microcracks.

A) THE BMI CONTROL SAMPLE CORRODED FOR 48 HR, VIEWED IN A REGION JUST ABOVE THE SALTWATER-JET FUEL INTERFACE. NOTE THE TRANSVERSE MICROCRACKING AND FLAKING OF THE RESIN

B) THE MATRIMID SAMPLE CORRODED FOR 48 HR, VIEWED IN A REGION JUST ABOVE THE SALTWATER-JET FUEL INTERFACE. NOTE THE TRANSVERSE MICROCRACKING AND FLAKING OF THE RESIN

**Figure 21.** 130x views of BMI control and Matrimid samples which corroded for 48 hr at 80°C. This view is taken just below the saltwater-jet fuel interface

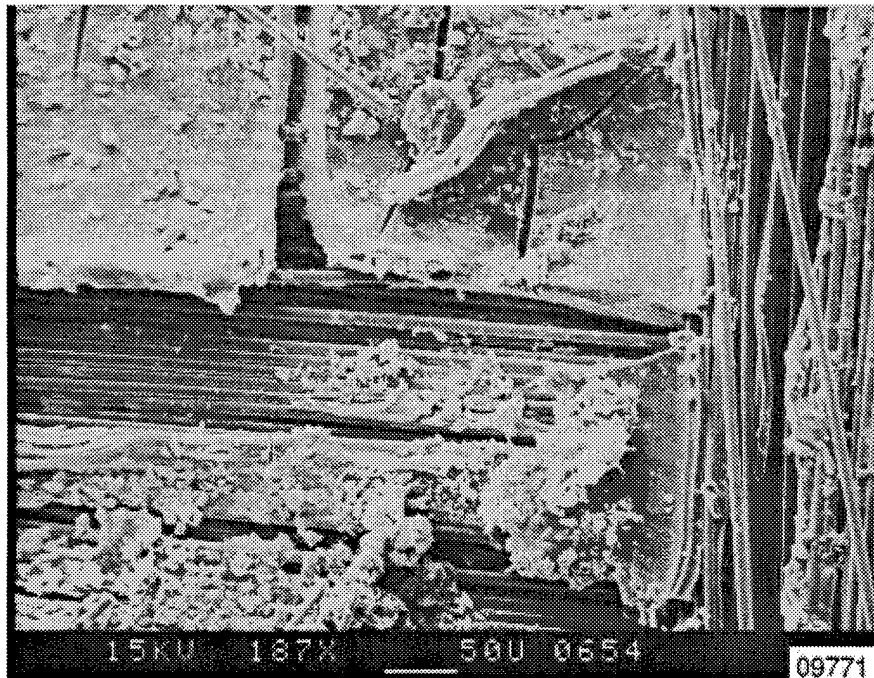
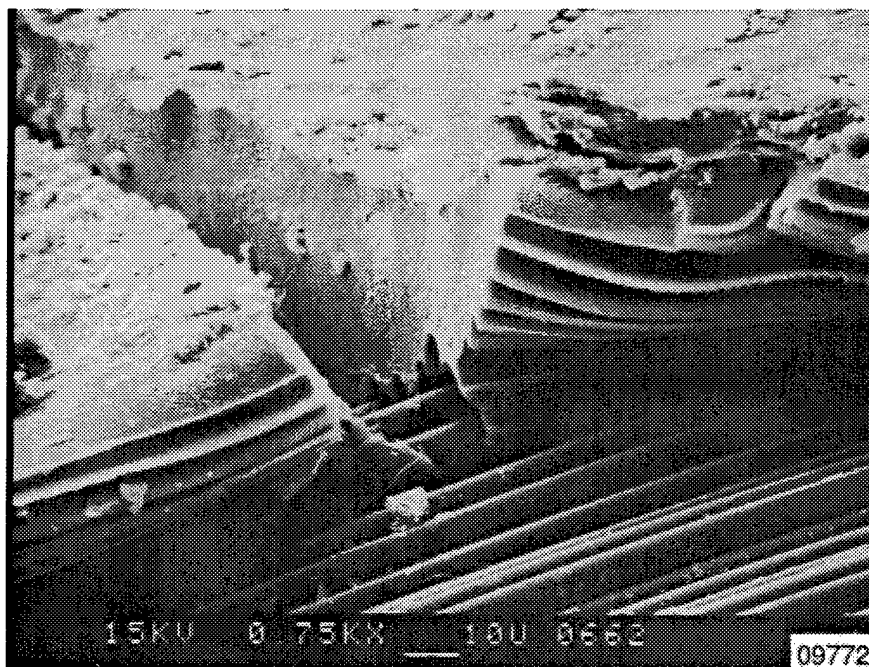
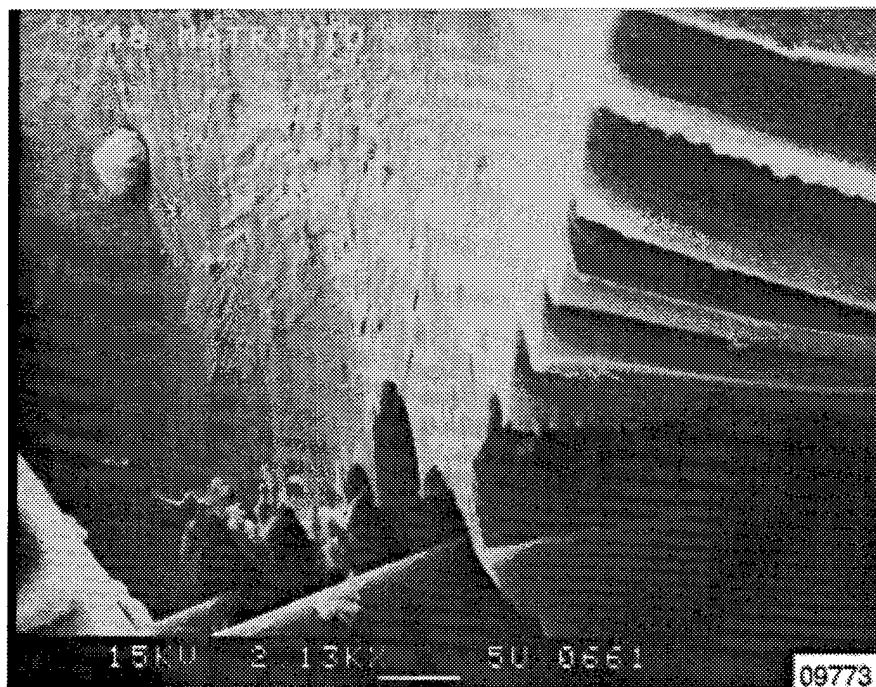
A) LOW MAGNIFICATION VIEW OF THE FLAKING AND PEELING INITIATION IN THE CENTER OF THE MICROGRAPH

B) HIGHER MAGNIFICATION VIEW OF FIGURE 22A WITH TILT INCREASED TO 65 DEG

**Figure 22. Examination of the flaking process in the Matrimid sample corroded for 48 hr at 80°C**

C) HIGHER MAGNIFICATION VIEW OF FIGURE 22B WITH TILT AT 65 DEG

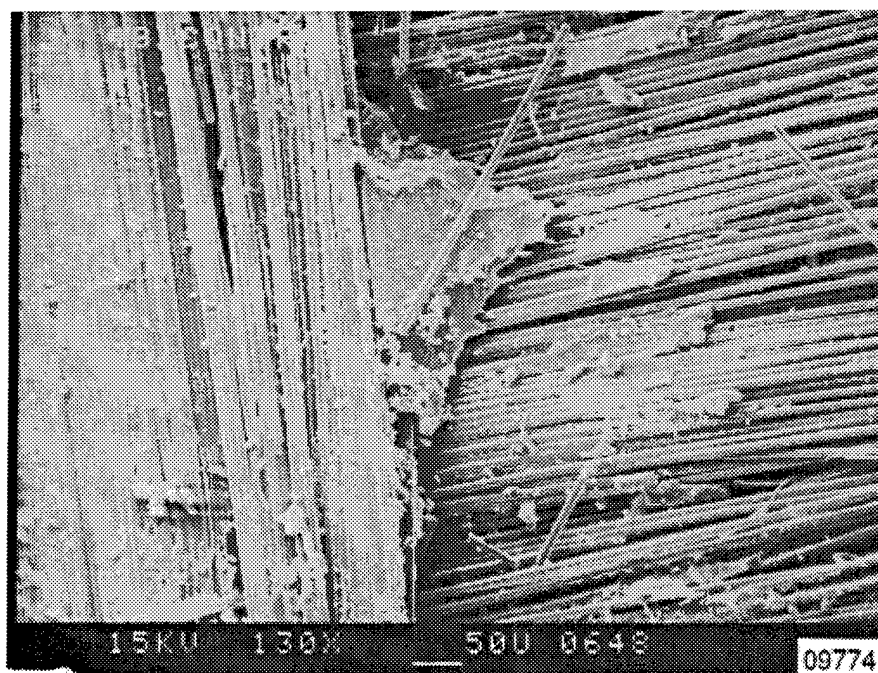
Above the saltwater-jet fuel interface, bare fibers are seen, as in Figure 23. Only small fragments of resin remain in regions where the resin was locally thick, such as in the resin pockets where the fiber tow dives beneath the surface of the weave structure. A resin rich pocket is illustrated in Figure 24.

**Figure 23. A view of the 48 hr corroded BMI control sample taken above the saltwater-jet fuel interface**

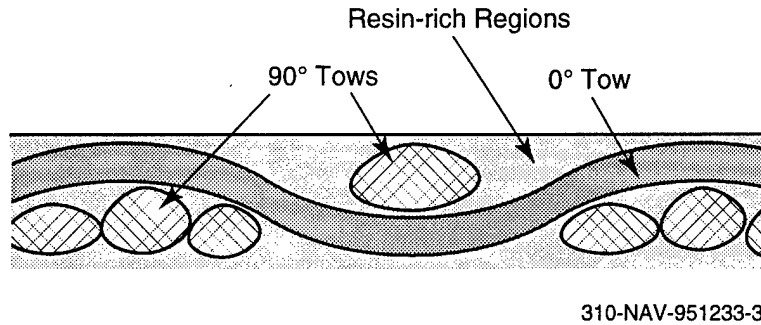
**Figure 24. End section of composite showing resin-rich regions on surface**

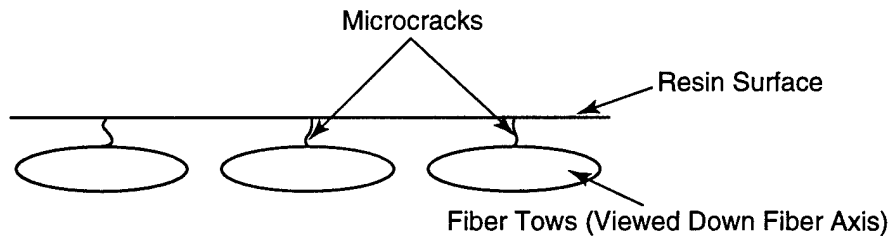
a) Microcracks Extend From Resin Surface To Fiber Tows

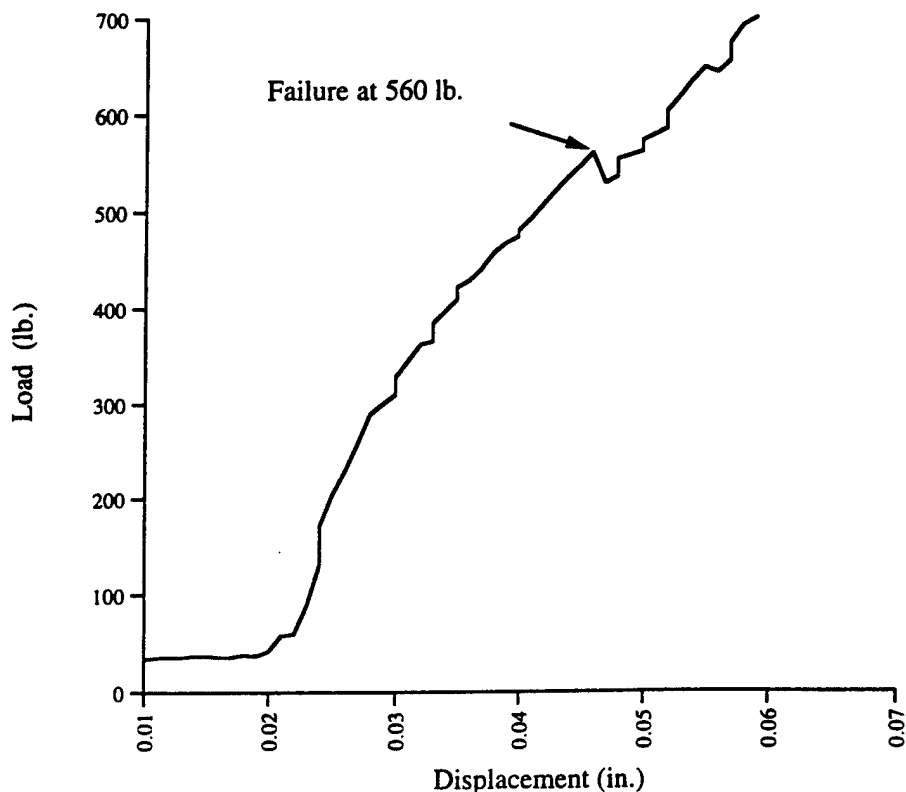
**Figure 26. Load-deflection plot for a control sample corroded 96 hr at 80°C**

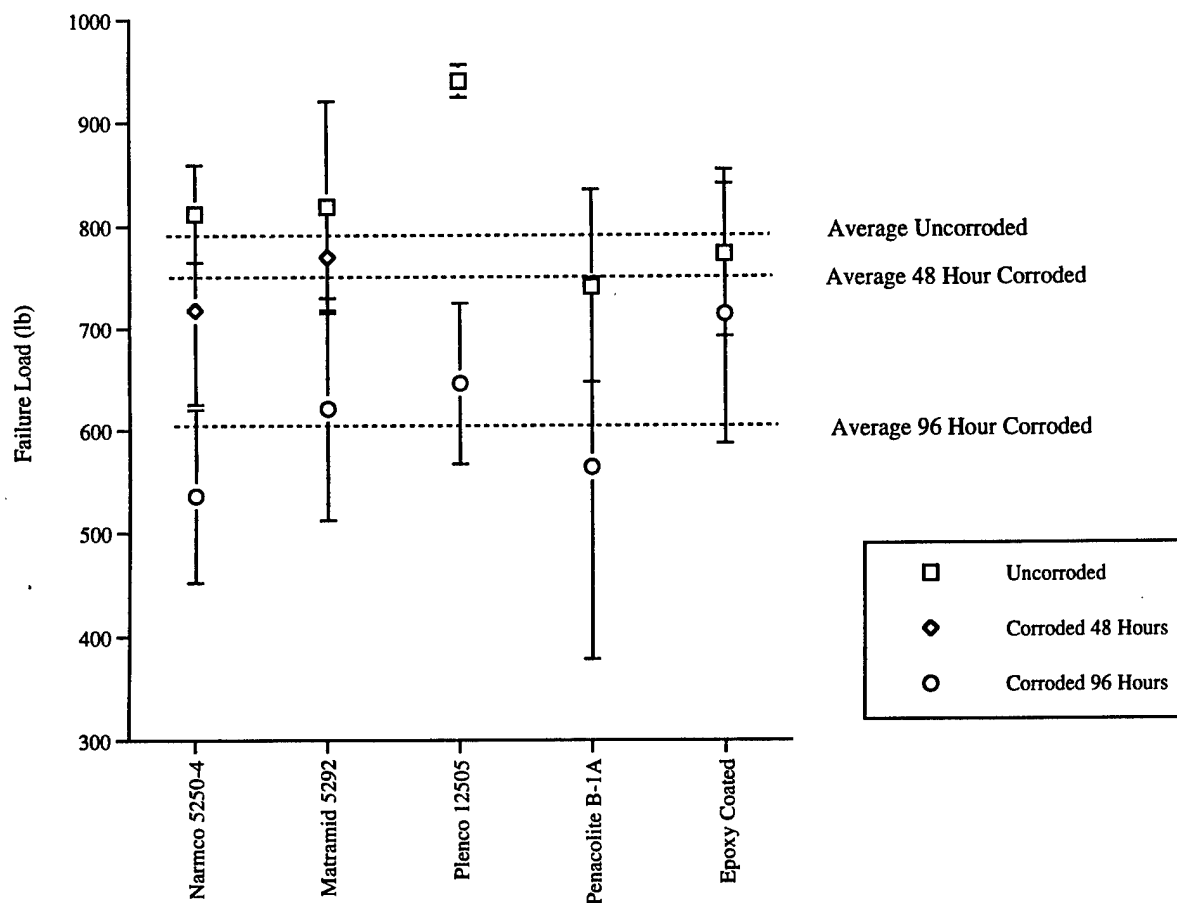
**Figure 27. Bolt bearing strength results for samples corroded at 80°C**
